FDM Data Processing for Cessna Caravan

Climb During Final Descent

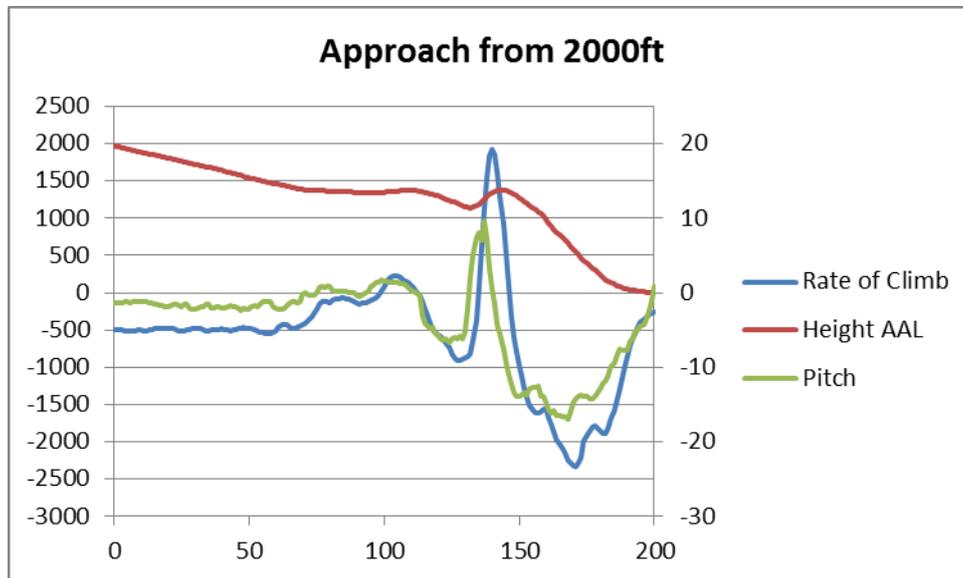
On this flight the aircraft was in the descent approaching Bukoba, flying level at about 1300ft above the airfield. The final descent towards the airport had started when the pilot climbed sharply 240ft before resuming the descent.

Rate Of Descent 1000 To 500 Ft Max	-2331.45	fpm
Pitch 1000 To 500 Ft Min	-17.02	deg
Pitch 500 To 20 Ft Min	-14.28	deg
Height 1 Mins To Touchdown	1347.134	ft

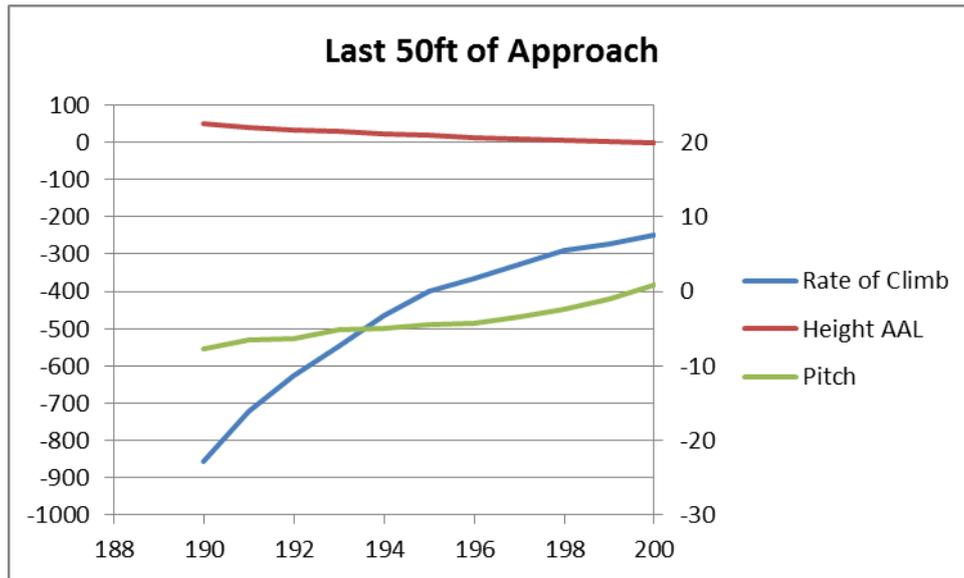
The short climb put the aircraft higher than normal, close to the runway, and in recovering the flight path a descent rate of 2330 fpm was reached at a height of 550 ft AAL. The aircraft was pitched nose down to the last second before touchdown, risking a nosewheel first landing.

As pure conjecture, the climb may have been to avoid a bird strike over the lake, however this is entirely guesswork and would need to be supported by a report from the crew concerned.

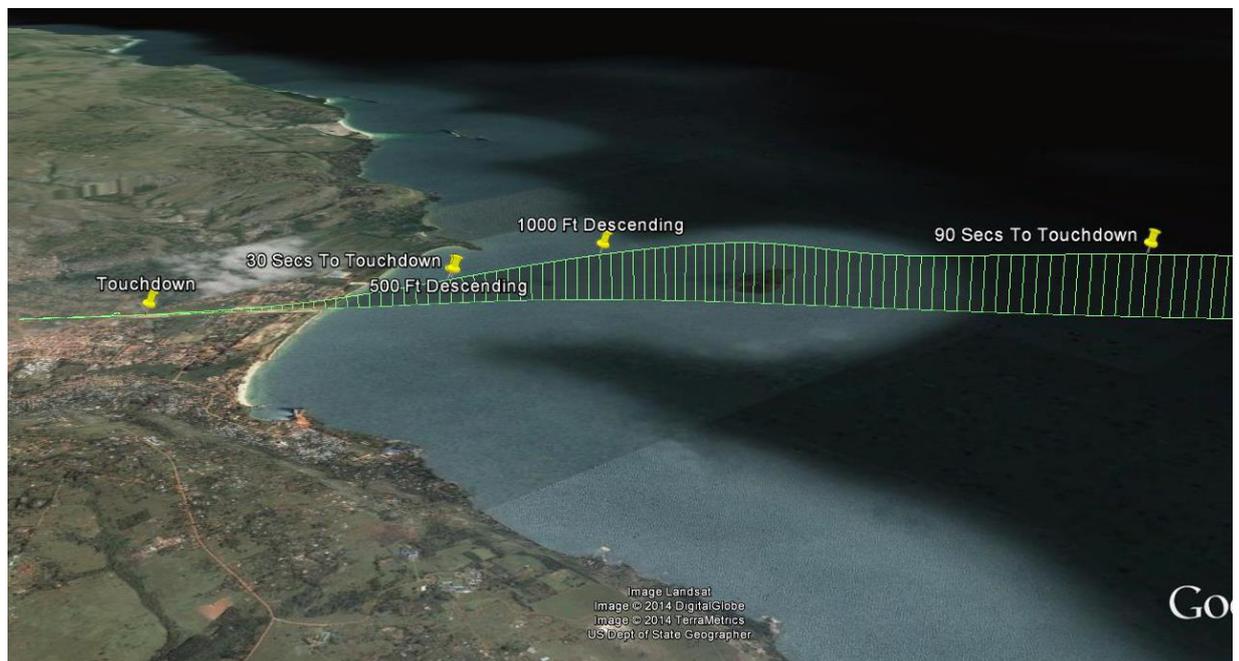
A Google Earth presentation of the final stages of the approach conveys this more easily.

Note: The indicated touchdown point is too far along the runway on this flight. This relates to the temporary configuration for this analysis and could be corrected in a production system.

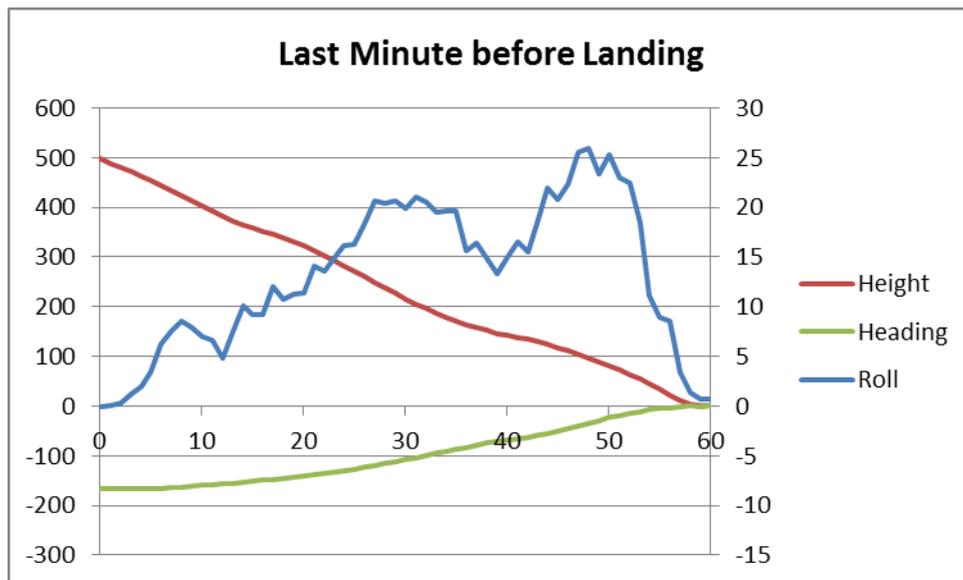
Plotting the data for the last minute before landing shows a 167 degree heading change with bank angles reaching 25 deg right wing low.

Heading Variation 300 To 50 Ft	119.9	deg
--------------------------------	-------	-----

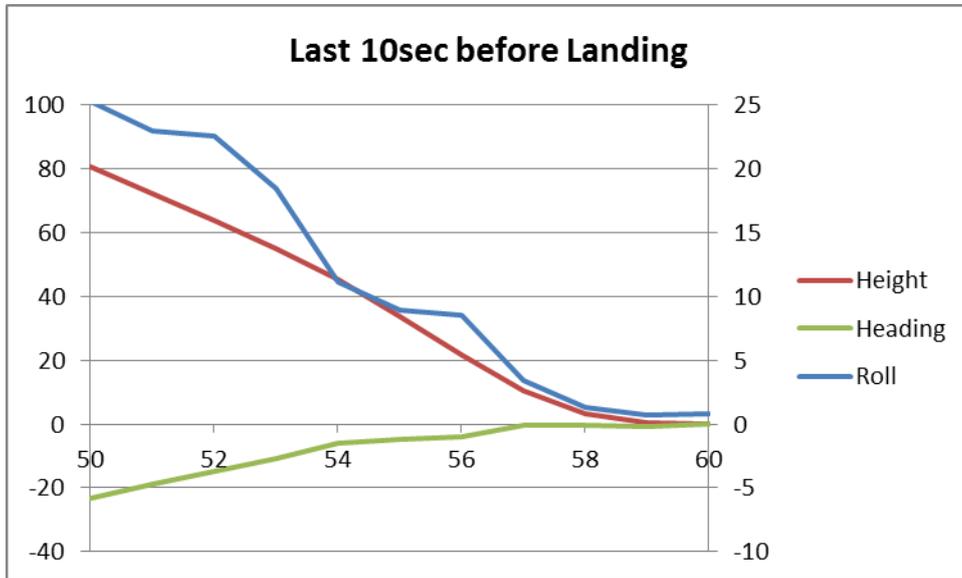
The last ten seconds show the aircraft only became wings level at about ten feet above the runway.

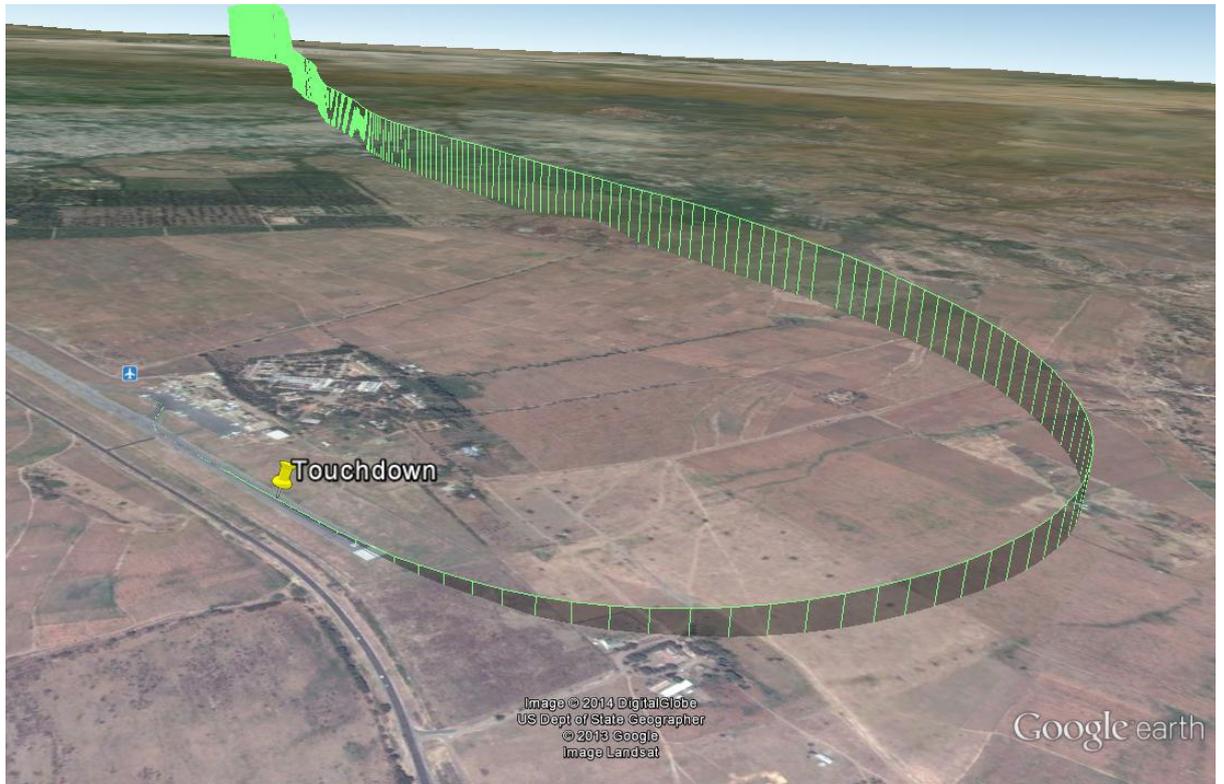
A Google Earth presentation of the final stages of the approach conveys this more easily.

This is one of the flights with a curving approach, where the aircraft is still turning late on the approach.

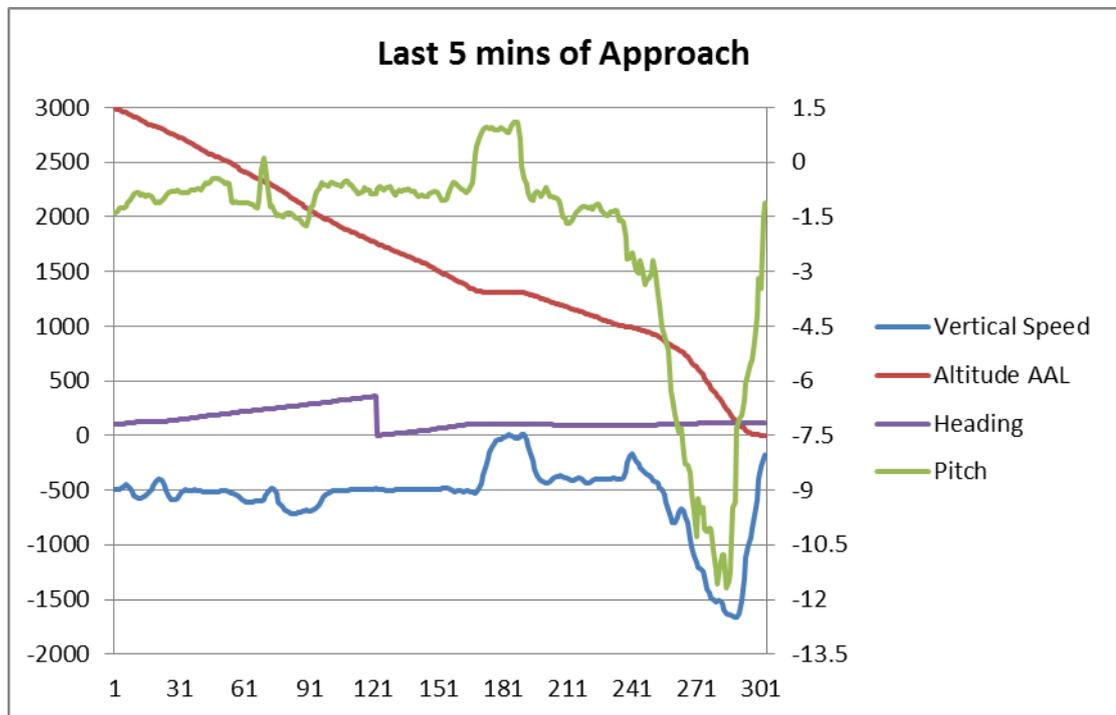
This is another flight where the pitch attitudes in the approach were low. This is especially curious as the pilot had carried out a descending turn and almost level section of flight before the final brief dip to the runway. The graph of descent characteristics shows the turn taking almost three minutes from 3000ft to about 1350ft, then a short level section of flight before the approach is continued, then in the last 45 seconds the approach steepens dramatically to land.

Pitch 20 Ft To Touchdown Min	-5.43	deg
------------------------------	-------	-----

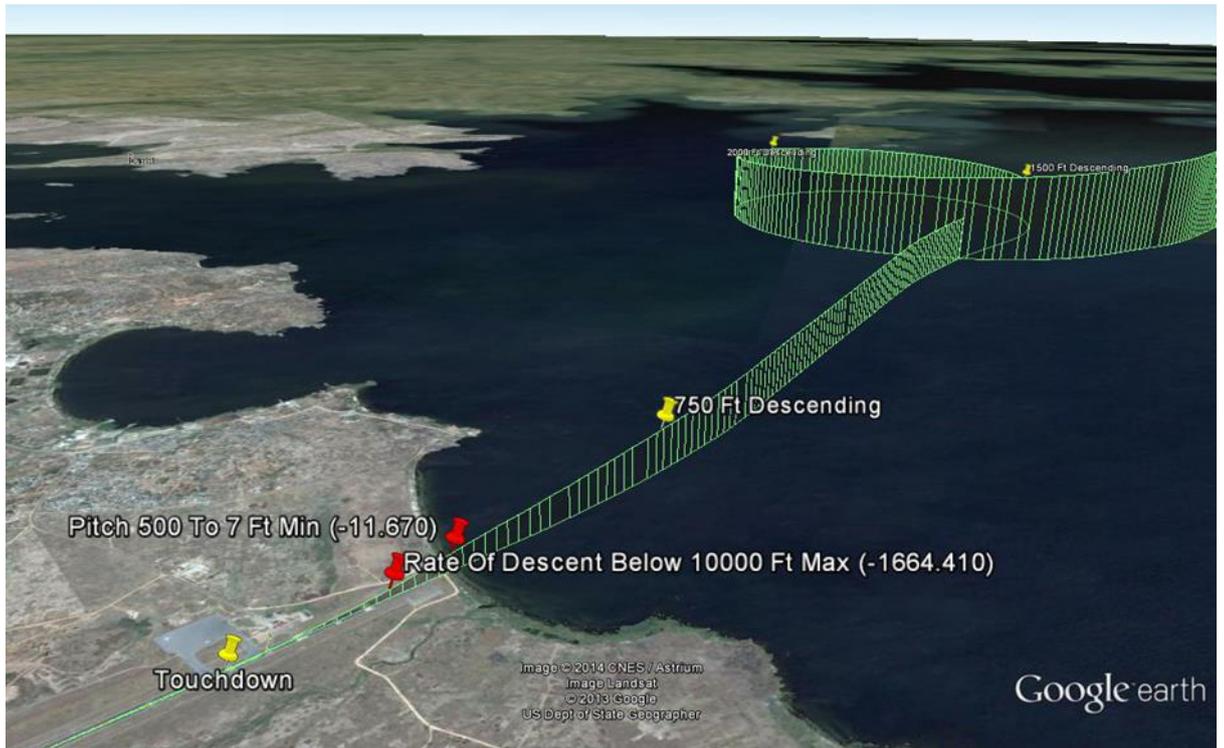
Again, a 3-D view of the approach is easier to interpret.
